LOGS AND DATA FROM TRENCHES ACROSS THE HAYWARD FAULT AT TYSON'S LAGOON (TULE POND), FREMONT, ALAMEDA COUNTY, CALIFORNIA

By
James J. Lienkaemper, Timothy E. Dawson, Stephen F. Personius, Gordon G. Seitz, Liam M. Reidy, and David P. Schwartz

2002

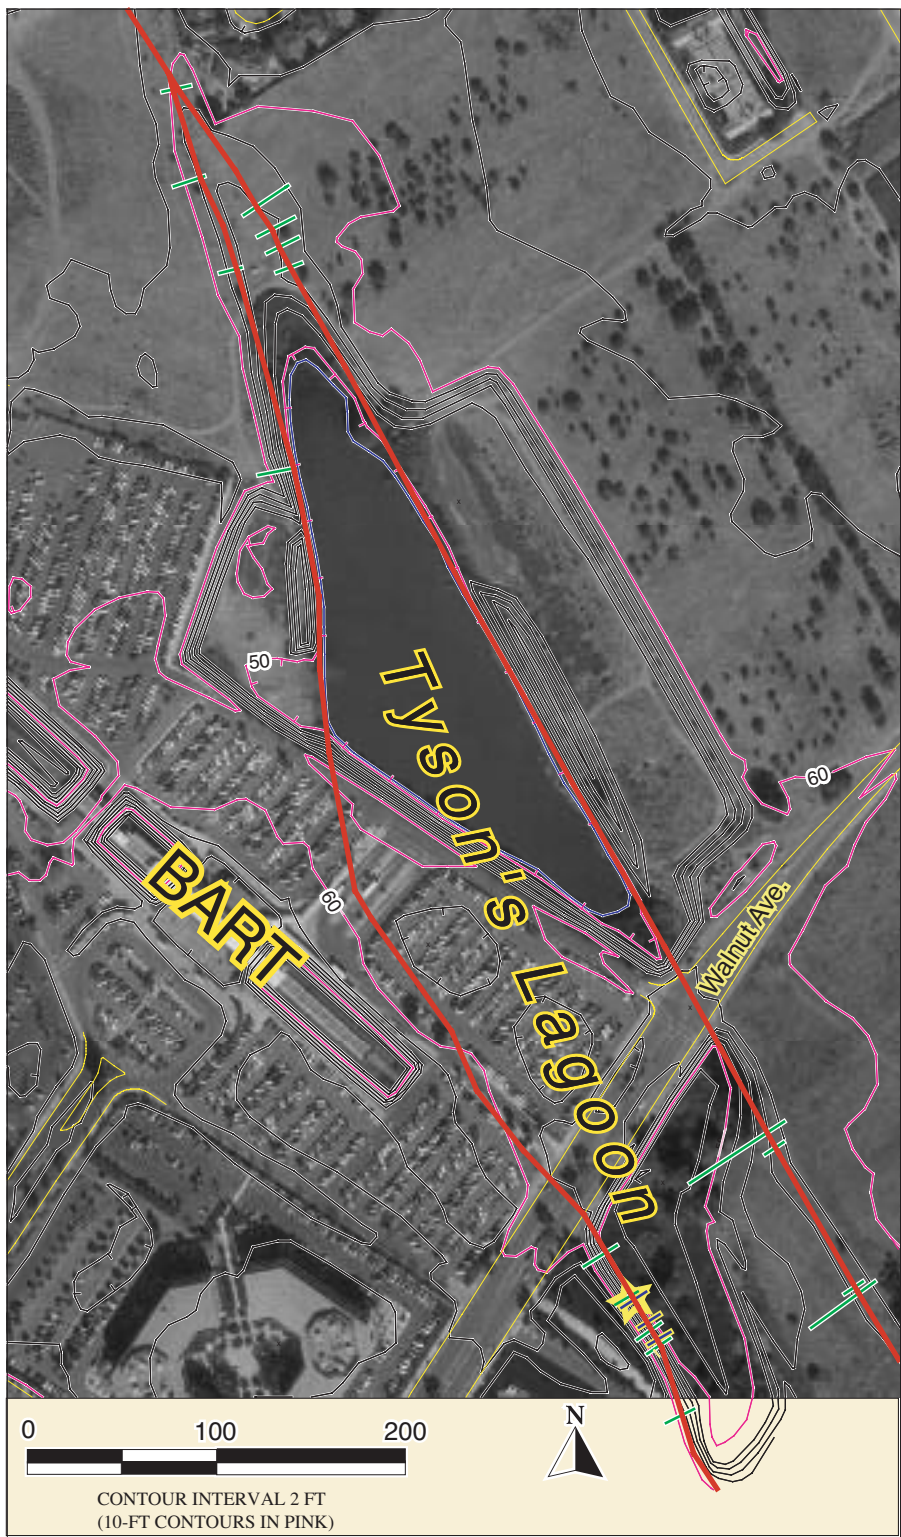
Figure 2. Map showing the Hayward Fault (red), which forms a closed depression or sag pond called Tyson's Lagoon (Tule Pond). Earlier trenches shown in green (Lienkaemper, 1992). Star indicates location of trench 00A. See figure 3 for detail of trench locations.

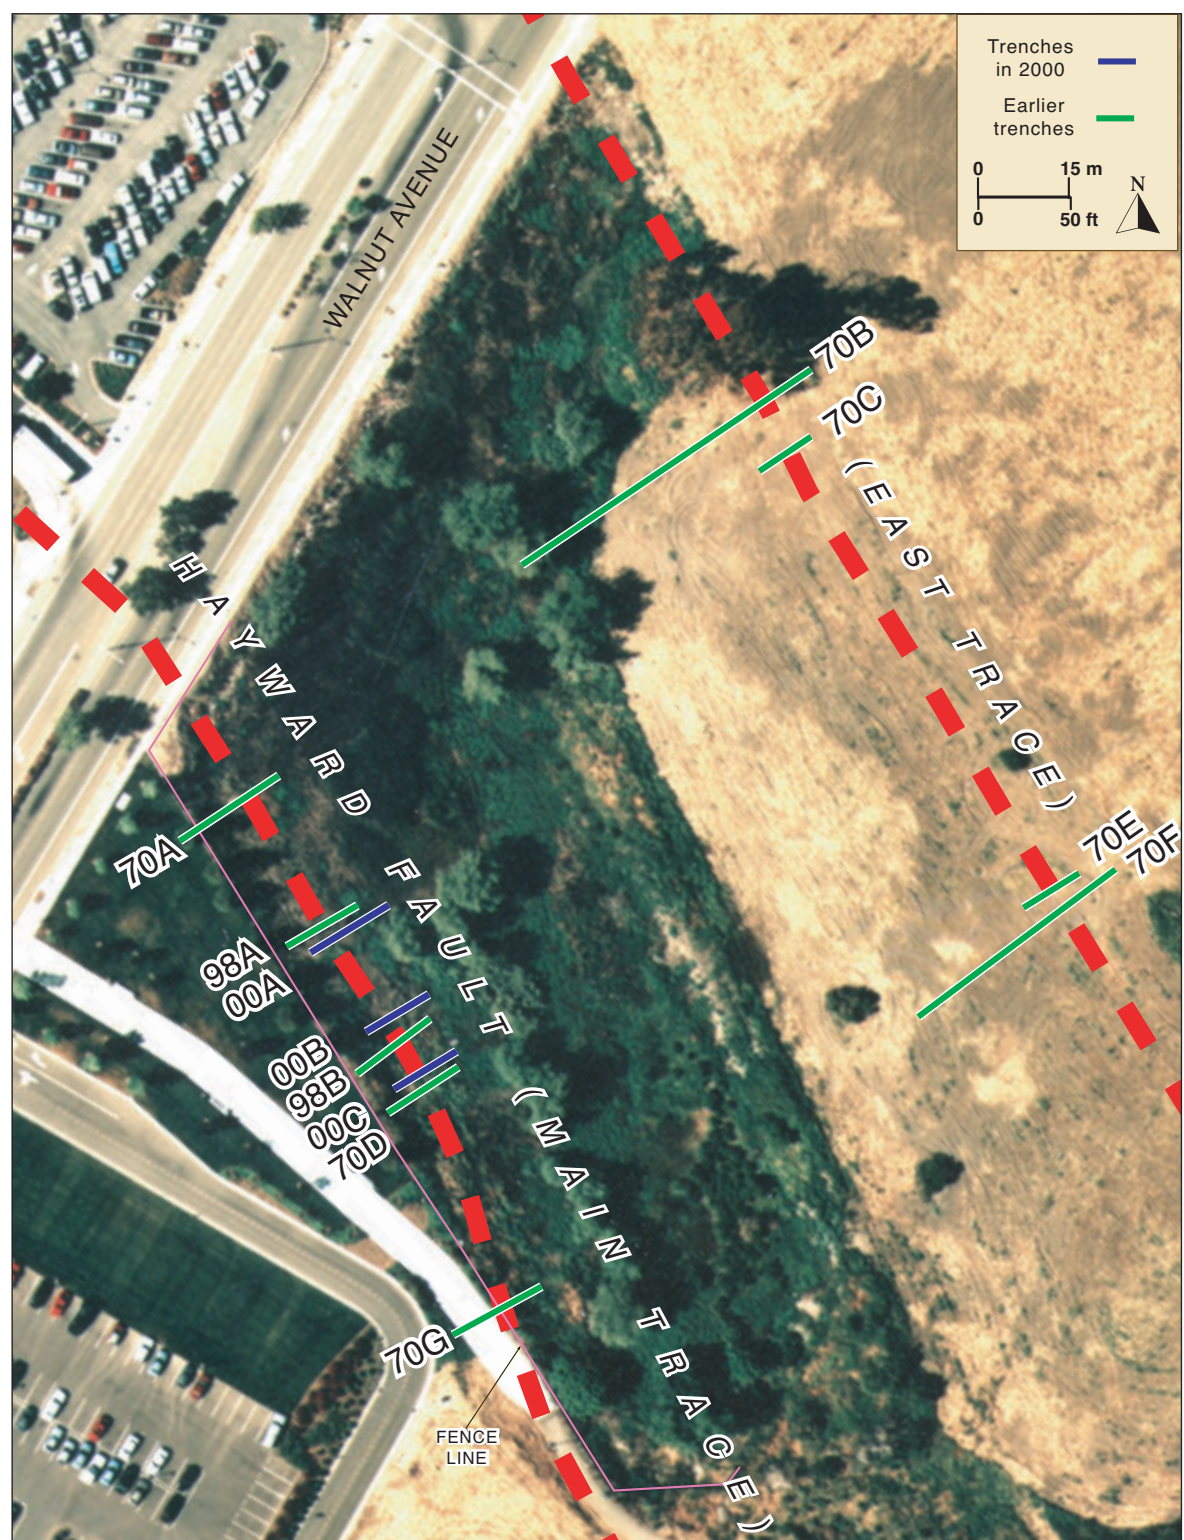
Figure 3. Map showing trench locations along the Hayward Fault, Tyson's Lagoon, south of Walnut Avenue.
